# Single Disk Scrub Head Plate Replacement Kit

T300, T300e, Speed Scrub 300 and A300 Single Disk Models

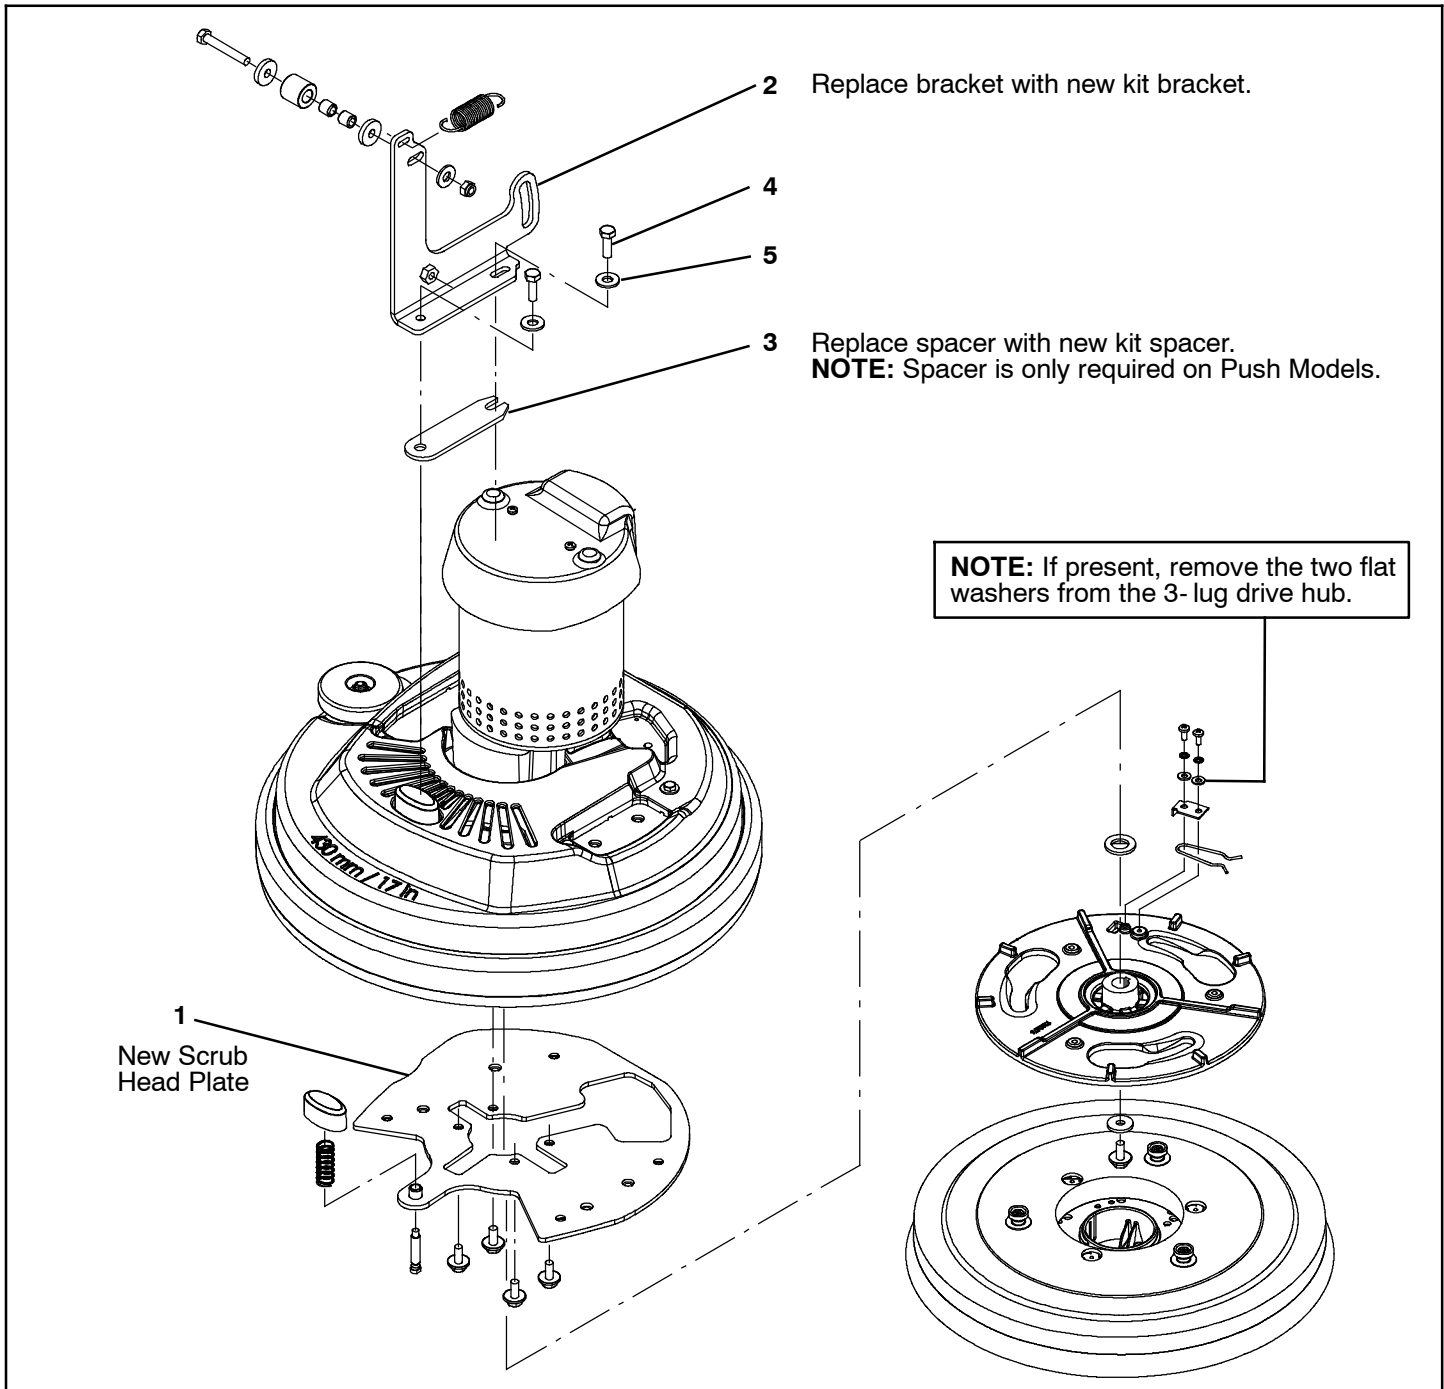
### 9014801 Kit Contents

**NOTE:** Scrub head plate p/n 1210590 was discontinued and replaced by this retrofit kit. The new plate was modified to eliminate any interference issues with drive hub. Install new plate using the supplied parts as described below.

Item	Part No.	Description	Qty.
1	1223980	Plate, Wldt, Head, Weighted	1
2	1223962	Bracket Wldt, Mtg, Head, 43D/50D, Tall	1
3	1223982	Spacer, Head, 4mm	1
4	12333	Screw, Hex, M8 x 1.25 x 25, SS,NL	2
5	01685	Washer, Flat, 0.38B 0.88D .08, SS	2

## INSTALLATION INSTRUCTIONS:
